Service Bulletin

American Honda Motor Co., Inc.

2001 - 2002 GL1800/GL1800A Rear Tire Inspection

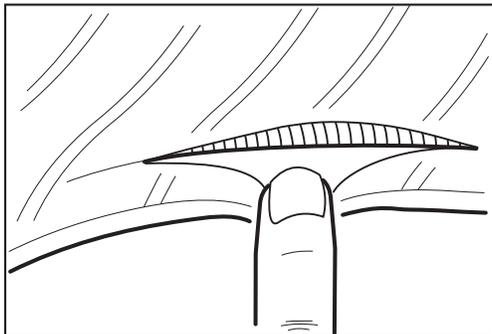
Inside Bead Injury

7. Carefully inspect the entire circumference of both tire beads. Inspect both the inside and outside of the bead for any distortion or injuries. See examples of injuries below.
8. If there is no evidence of bead damage, re-install the tire on the rim. Be sure to use plenty of commercially available tire lubricant on the inside and outside of both beads. Be sure to align the balance dot with the valve stem. Inflate the tire to 41 psi. Install the wheel assembly on the motorcycle and proceed to the *Identification* and then to the *Warranty* section.
9. If any damage or injury is present replace the tire and valve stem. Be sure to use plenty of commercially available tire lubricant on the inside and outside of both beads. Balance the new tire as necessary.

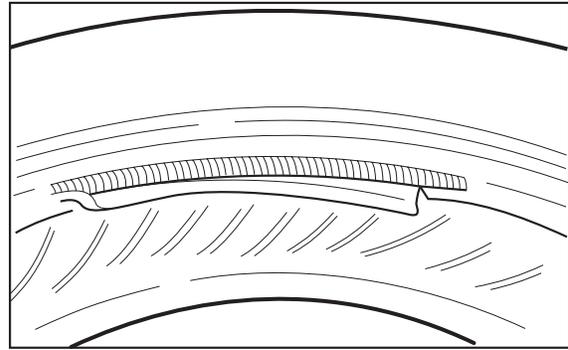
Outside Bead Injury

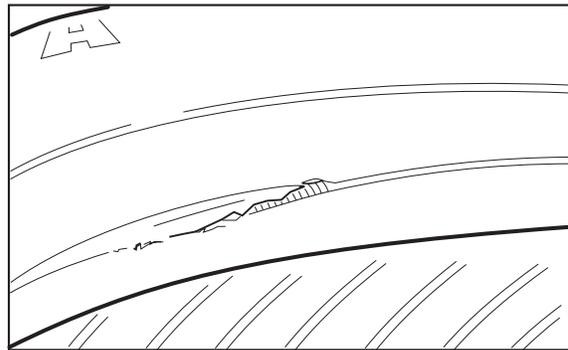
Outside Bead Injury
