Service Bulletin

American Honda Motor Co., Inc.

2001 - 2002 GL1800/GL1800A Rear Tire Inspection

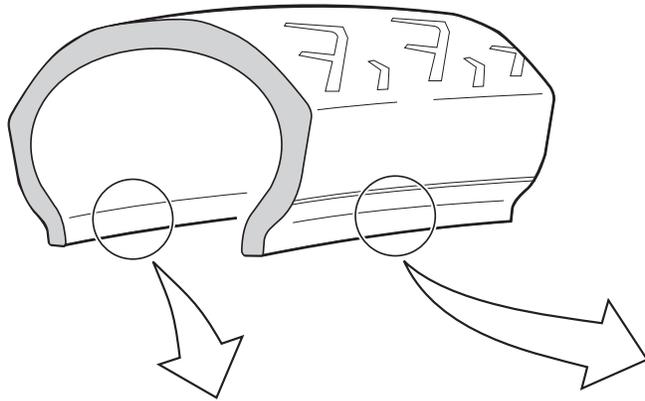
Inside Bead Injury

This service campaign includes all 2001 GL1800 Gold Wing models and certain 2002 models. A small percentage of the original equipment rear tires installed on these models could have been damaged during the factory assembly process. As a result, the tire bead may not seal properly against the rim. This condition will allow slightly faster than normal air pressure loss. An under inflated tire may cause abnormal wear patterns and can overheat the tire causing the tread to crack. Normally, tires in good condition may lose one to two psi per month if not checked and adjusted regularly.

7. Carefully inspect the entire circumference of both tire beads. Inspect both the inside and outside of the bead for any distortion or injuries. See examples of injuries below.
8. If there is no evidence of bead damage, re-install the tire on the rim. Be sure to use plenty of commercially available tire lubricant on the inside and outside of both beads. Be sure to align the balance dot with the valve stem. Inflate the tire to 41 psi. Install the wheel assembly on the motorcycle and proceed to the *Identification* and then to the *Warranty* section.
9. If any damage or injury is present replace the tire and valve stem. Be sure to use plenty of commercially available tire lubricant on the inside and outside of both beads. Balance the new tire as necessary.
